**Flood Control Project Maintenance
Levee Inspections**

Fall 2012 Levee Maintenance Deficiency Summary Report

Sacramento River Basin

Sutter Maintenance Yard Tisdale Bypass

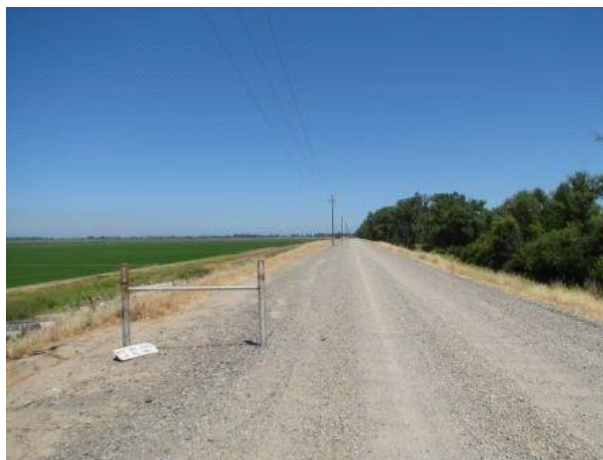
Levee Mile Report Line	4
Start Levee Mile	2.18
End Levee Mile	4.10
Location	Land Side
Category	Earthen Levee
Item	Encroachments

View of the PG&E poles along the landside crown of the levee.

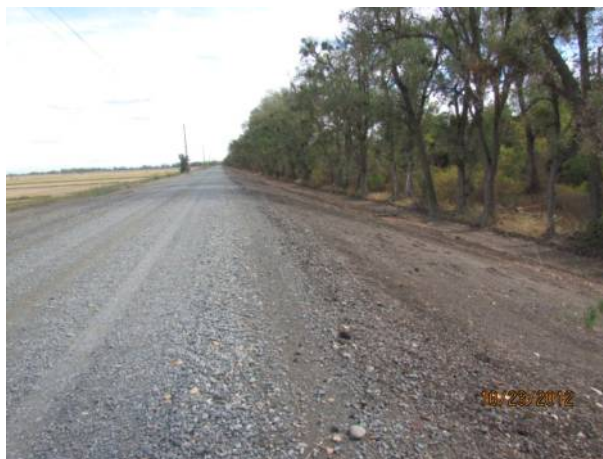
Levee Mile Report Line	5
Start Levee Mile	2.77
End Levee Mile	2.77
Location	Water Side
Category	Earthen Levee
Item	Vegetation

View of the levee with no vegetation on both slopes.

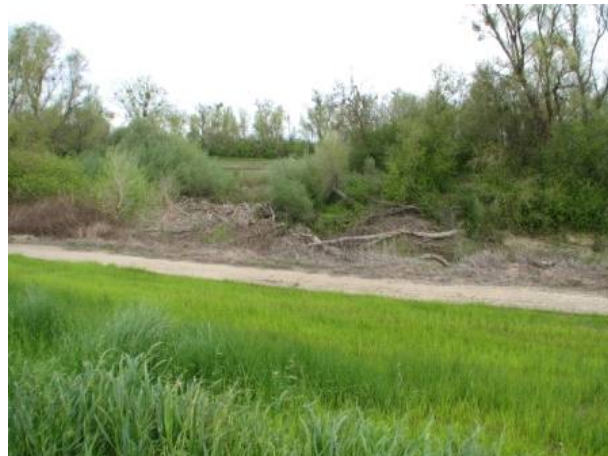
Levee Mile Report Line	3
Start Levee Mile	1.01
End Levee Mile	1.01
Location	Water Side
Category	Earthen Levee
Item	Erosion / Bank Caving

View of the erosion along the waterside toe of the levee.

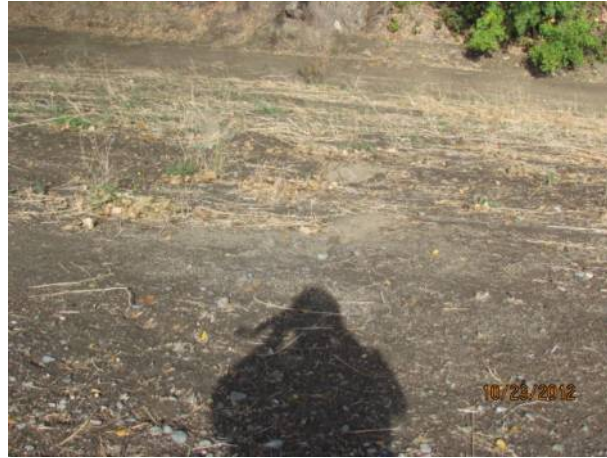
Levee Mile Report Line	4
Start Levee Mile	2.53
End Levee Mile	2.53
Location	Water Side
Category	Earthen Levee
Item	Animal Control

View of the rodent holes along the landside slope.
